Analysis of Structural Damage and Disaster Management Resulting from Earthquakes in Cianjur

Sudarno P Tampubolon*

Civil Engineering Study Program, Indonesian Christian University, Indonesia

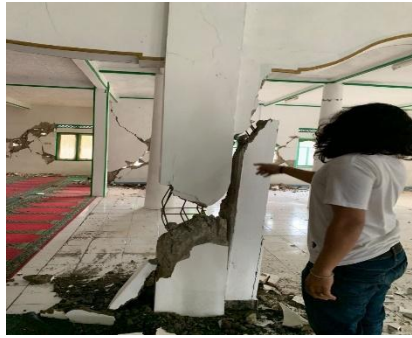
From the assessment conducted by the team from the Civil Engineering Program at FT UKI from December 12 to 17, 2022, several images were obtained showing the damage and collapse patterns of various residential buildings and public facilities in Cianjur. Figure 3 below illustrates the failure that occurred in the column structure due to the column's inability to withstand the applied loads and poor design for supporting axial loads and beams. The image shows that the column can no longer properly support the beams and roof framework.

Figure 3: Column Structure Failure Unable to Support Beam and Roof Framework

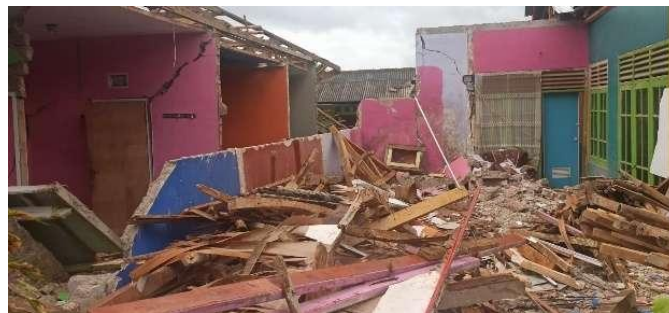
In addition to the column failures, several structural failures in the beams were also identified. Figure 4. below shows the structural failure in the beam due to the inadequate connection between the beam and the column.

Figure 4: Beam Structure Failure Due to Poor Design for Load Bearing

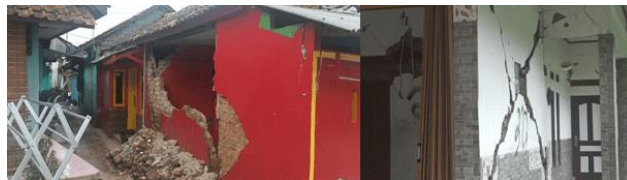
Structural damage was also found in the installation of house walls, where bricks or concrete blocks were not anchored during installation. This can be seen in Figure 6 below, where the house wall collapsed due to the lack of anchors to bind the bricks or concrete blocks used.

Figure 5: Photo of Wall Collapse Due to Poor Design and Lack of Anchors/ Reinforcement in the Columns to Bind the Wall

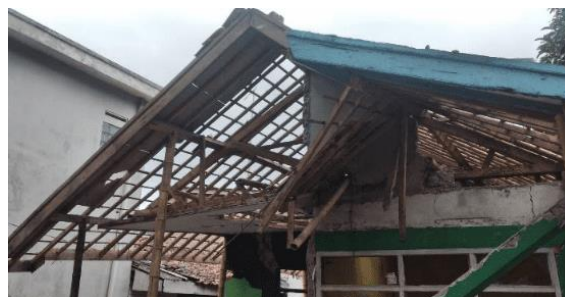
Structural failures were also found in the roof structure. The assessment revealed that the connections in the roof trusses were inadequate, resulting in many roof joint failures, as shown in Figure 6.

Figure 6: Failure of Connections in the Wooden Roof Frame

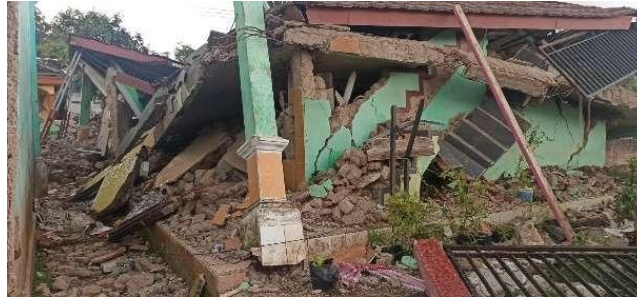
Cianjur Regency is highly susceptible to earthquakes due to the influence of potential faults that cause ground movements. These ground movements are expected to lead to surface fault hazards and collateral hazards such as ground cracks, subsidence, landslides, and even liquefaction. These issues can potentially reduce the bearing capacity of foundations to support loads. Ground movement can also cause foundation shifting or overturning. Foundations are a critical part of the substructure that must be carefully analyzed and installed in the field. Structural failure of the foundation can result in the collapse of the building, causing columns and beams to fail. Post-earthquake inspections in Cianjur revealed that foundation installations lacked attention to detail in joint connections and reinforcement placement, as shown in Figure 7.

Figure 7: Foundation Structure Failure in Supporting Axial and Vertical Loads

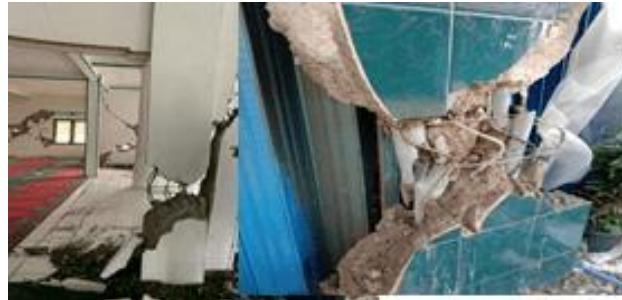
Failures in rebar hooks are commonly encountered in the field due to a lack of understanding of the use of hooks or stirrups in reinforcement. Proper bending details for rebar/hooks are crucial to anticipate collapse patterns (shear force/axial force) in beam and column structures [7]. SNI-2847-2019 specifies standard hook types, including 90° hooks, 180° hooks, stirrup hooks, and tie reinforcement hooks with $< 135^\circ$. Figure 10 shows the use of rebar hooks that do not comply with these standards.

Figure 8: Failure in Rebar Hook Installation in Columns
