Comparison of High-Rise Building Structural Performance Using Response Spectrum Method SNI 03-1726-2019 and FEMA-154 Rapid Visual Screening (RVS)

Abstract

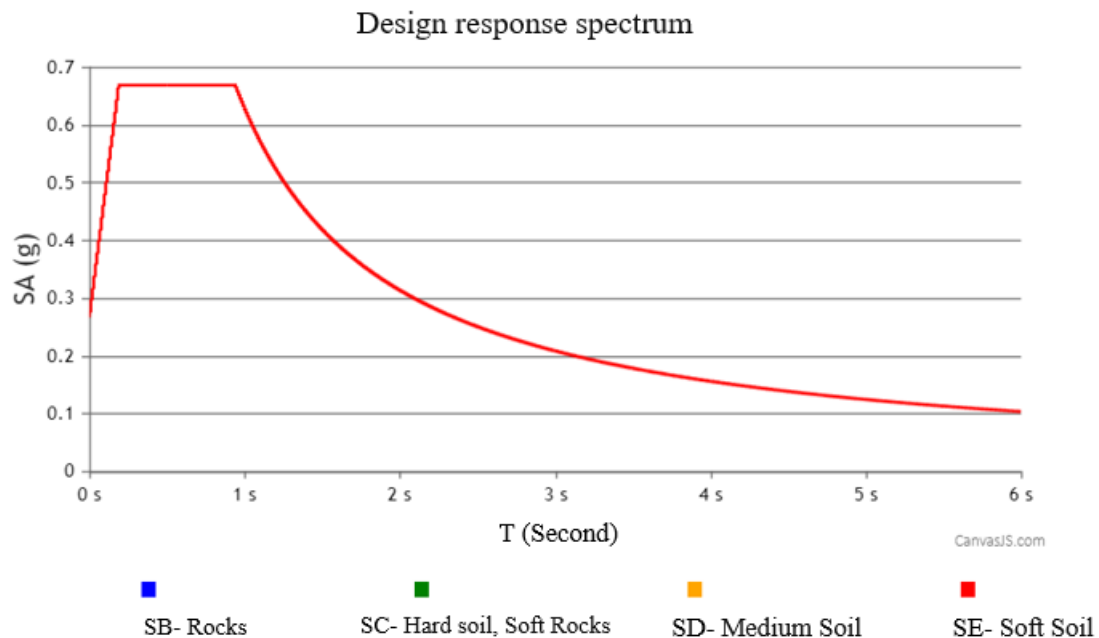
Figure 3. Design Response Spectrum

Spectrum response is an analysis used in solving dynamic equations due to earthquake loads, especially for linear systems. Furthermore (Mallisa, Zet., 2008) stated that spectrum analysis is a simple analysis and only requires a short time. Based on SNI 03-1726-2019, it is stated that the spectrum response is a plot of the peak response (displacement, speed and acceleration) of a series of oscillators that have various natural frequency variations and are driven by vibrations.

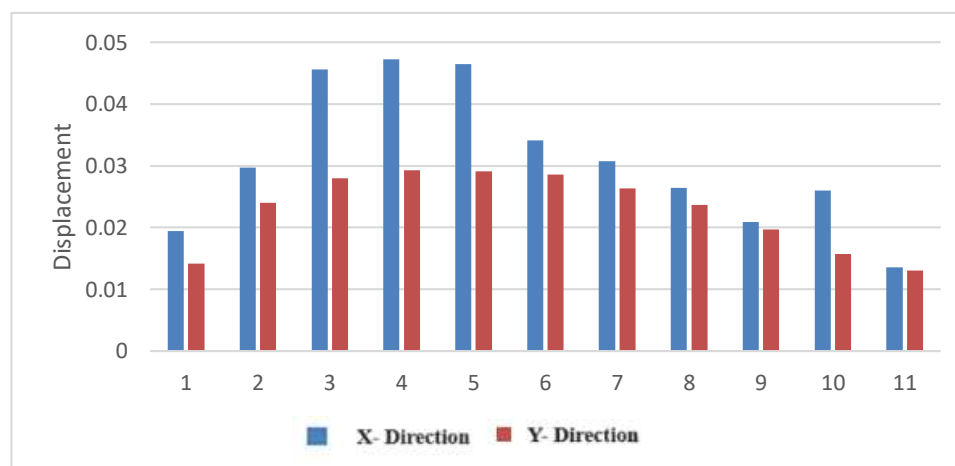
Figure 5. Inter Story Drift Ultimate

Table 6. Inter Story Drift Ultimate

1. Rapid Visual Screening (RVS) method using FEMA-154 as an evaluation reference, it was found that the building studied had met the cut-off ($s > 2$) on the level 1 form but experienced a decrease in value. S on form level 2 ($s = 1$) but is still in safe condition, because the minimum value of s is at level 2 or $S_{\min} = 0.3$.
2. In the analysis results it was found that the participating mass ratio reached 100% in the 31st mode in the X direction and reached 100% in 29th mode in Y direction.
3. Value of inter story drift limit for X-direction 0.0135-0.047 and Y-Direction 0.0129-0.0292. These values are still below the specified limit of 0.08
